# Bus Stop Amenities Study

## Equity and Accessibility

Rachel Inman

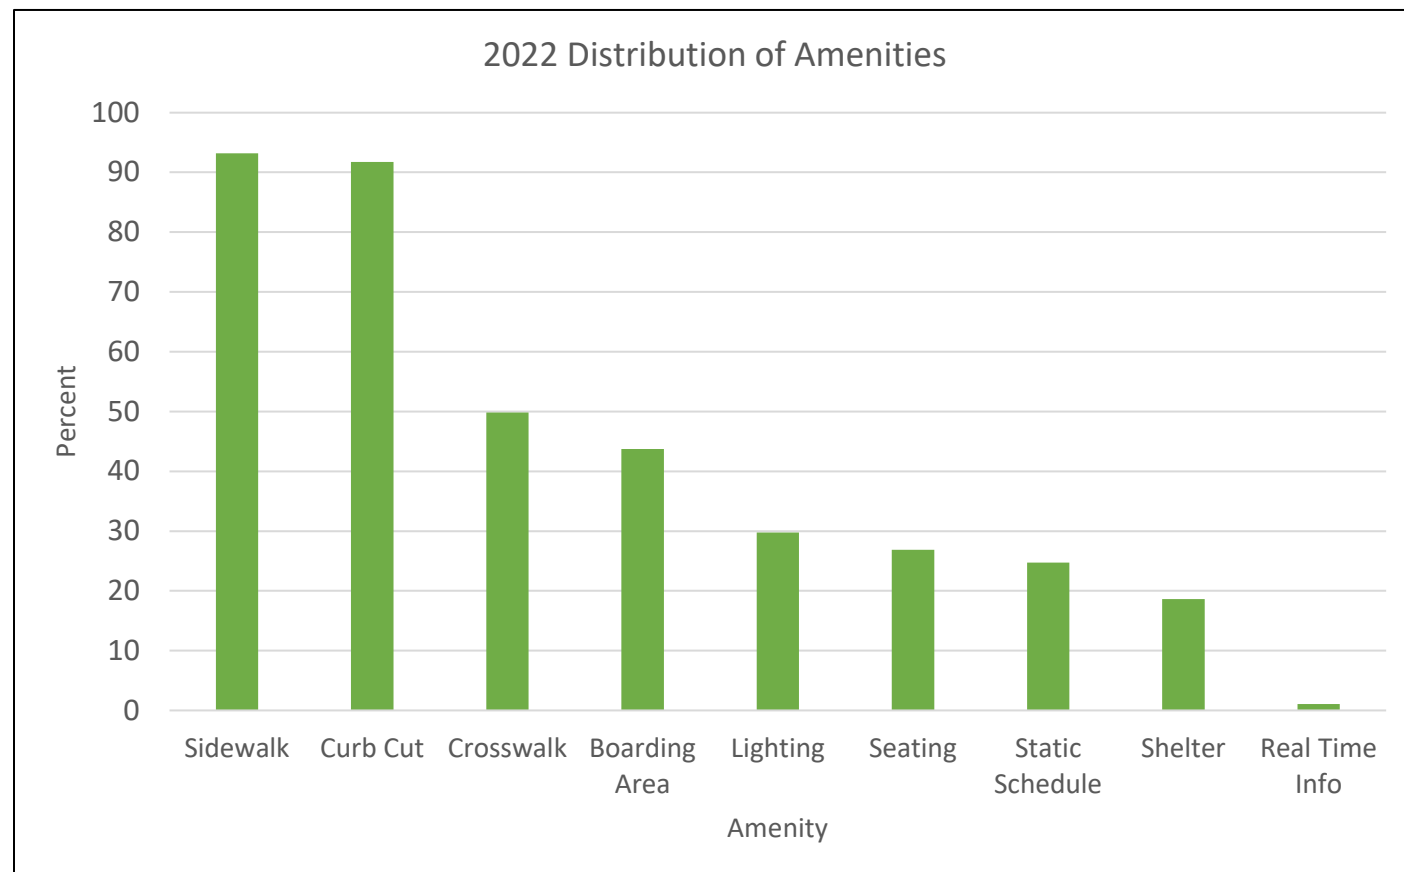
- 93% of stops feature a sidewalk
  - Only 44% of stops feature a boarding area
  - 43% connected to a boarding area
- Infrastructure amenities all 30%>=
  - Shelters offered at 19% of stops
- All stop feature an identifying marker
  - 25% provide a static schedule
  - Only 1% (3 stops) provide real-time information

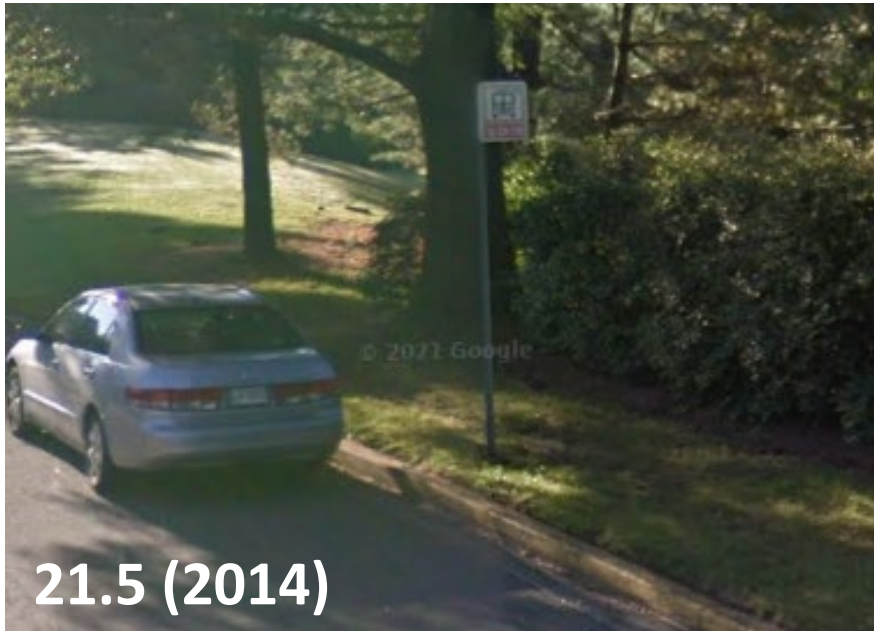
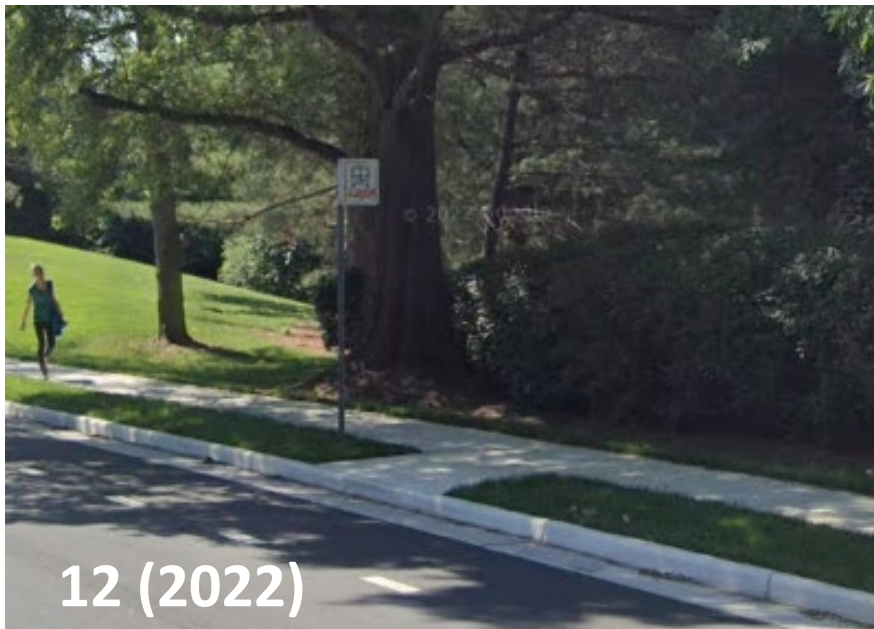
# Priority Matrix

- Higher score = Higher priority for upgrades
- Score interpretations:
  - 20.5+ points: High priority
  - 10.5 - 20 points: Considered
  - 10=> points: Low priority

- Emphasis on accessibility
- Higher score = Higher priority for upgrades
- Score interpretations:
  - 20.5+ points: High priority
  - 10.5 - 20 points: Considered
  - 10=> points: Low priority

Accessibility	
3.5 points	Curb cut does not exist at nearest sidewalk ending
3 points	Marked crosswalk does not exist within 200 ft
2.5 points	Sidewalk does not exist
2 points	Connection to sidewalk does not exist

1.5 points	Designated boarding area does not exist
Infrastructure	
2 points	Lighting does not exist within 20 ft
1.5 points	Designated shelter does not exist
1 point	Designated seating does not exist
Information

1.5 points	Static schedule does not exist
1 point	Static map does not exist
0.5 points	Real-time information does not exist
Average Total Daily Ridership

0.5 points	1 - 10 Total ridership
1 point	11 - 20 Total ridership
1.5 points	21 - 100 Total ridership
2 points	100+ Total ridership
Average Weekly Trips	
0.5 points	200 >= Weekly trips
1 point	201 - 500 Weekly trips

1.5 points	501 - 700 Weekly trips
2 points	700+ Weekly trips
Routes Served	
0.5 points	2 - 3 Routes
1 point	4 - 6 Routes
1.5 points	7+ Routes
